Kearl Seepage – Investigation Results

May 5, 2023

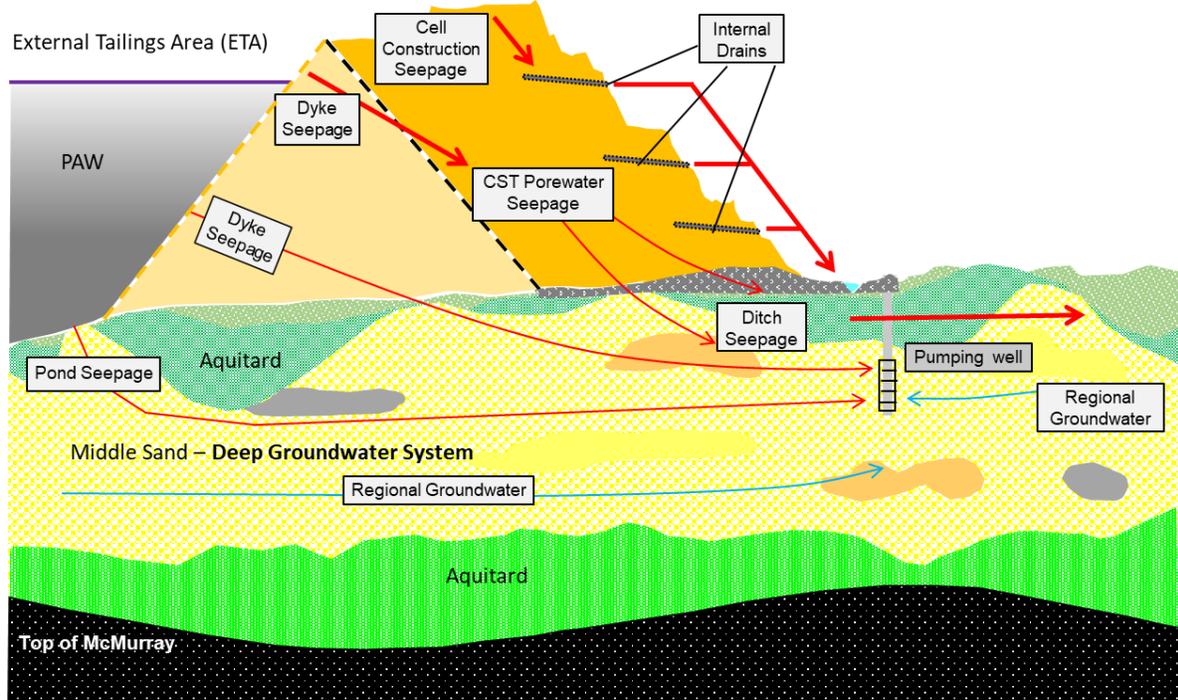
Construction methods for on-lease infrastructure, such as roads, piping infrastructure, and the ETA dyke itself, placed sand fill material which created an unexpected pathway through shallow groundwater systems. This permeable sand fill layer allowed industrial wastewater from on-lease sources to flow above the elevation of the SIS detection and pumping wells, eventually appearing at surface.

- Dyke seepage: process affected water moving through the tailings dyke
- Pond seepage: process affected water moving through the base of the ETA structure
- Cell construction seepage: run-off from the dyke construction process
- Coarse Sand Tails (CST) pore water seepage: fluids released from the CST stream
- Ditch seepage: process affected water from site water collection ditch infrastructure

The SIS is designed to detect seepage of industrial wastewater via regular sampling and monitoring for known chemical markers. Once detected, pumping wells are activated to return the affected water to the ETA for ongoing storage and for use in the production processes. The SIS design did not account for a shallow groundwater seepage mechanism via the sand fill layer placed during construction, and therefore did not detect nor capture the industrial wastewater as it flowed off lease.
